Please find enclosed Revision 1 of the Rocky Flats Cleanup Agreement Type 1 Closeout Report provided for your approval for Building 995 Complex and the Sanitary Sewer System. Revision 1 reflects changes made based on comments received from the Colorado Department of Public Health and Environment.

**BUILDING 995/SANITARY SEWER CLOSEOUT REPORT RESPONSE – DWF-068-05**

## Facility Descriptions, Operation and Closure of the Sanitary Collection and Treatment Systems at RFETS

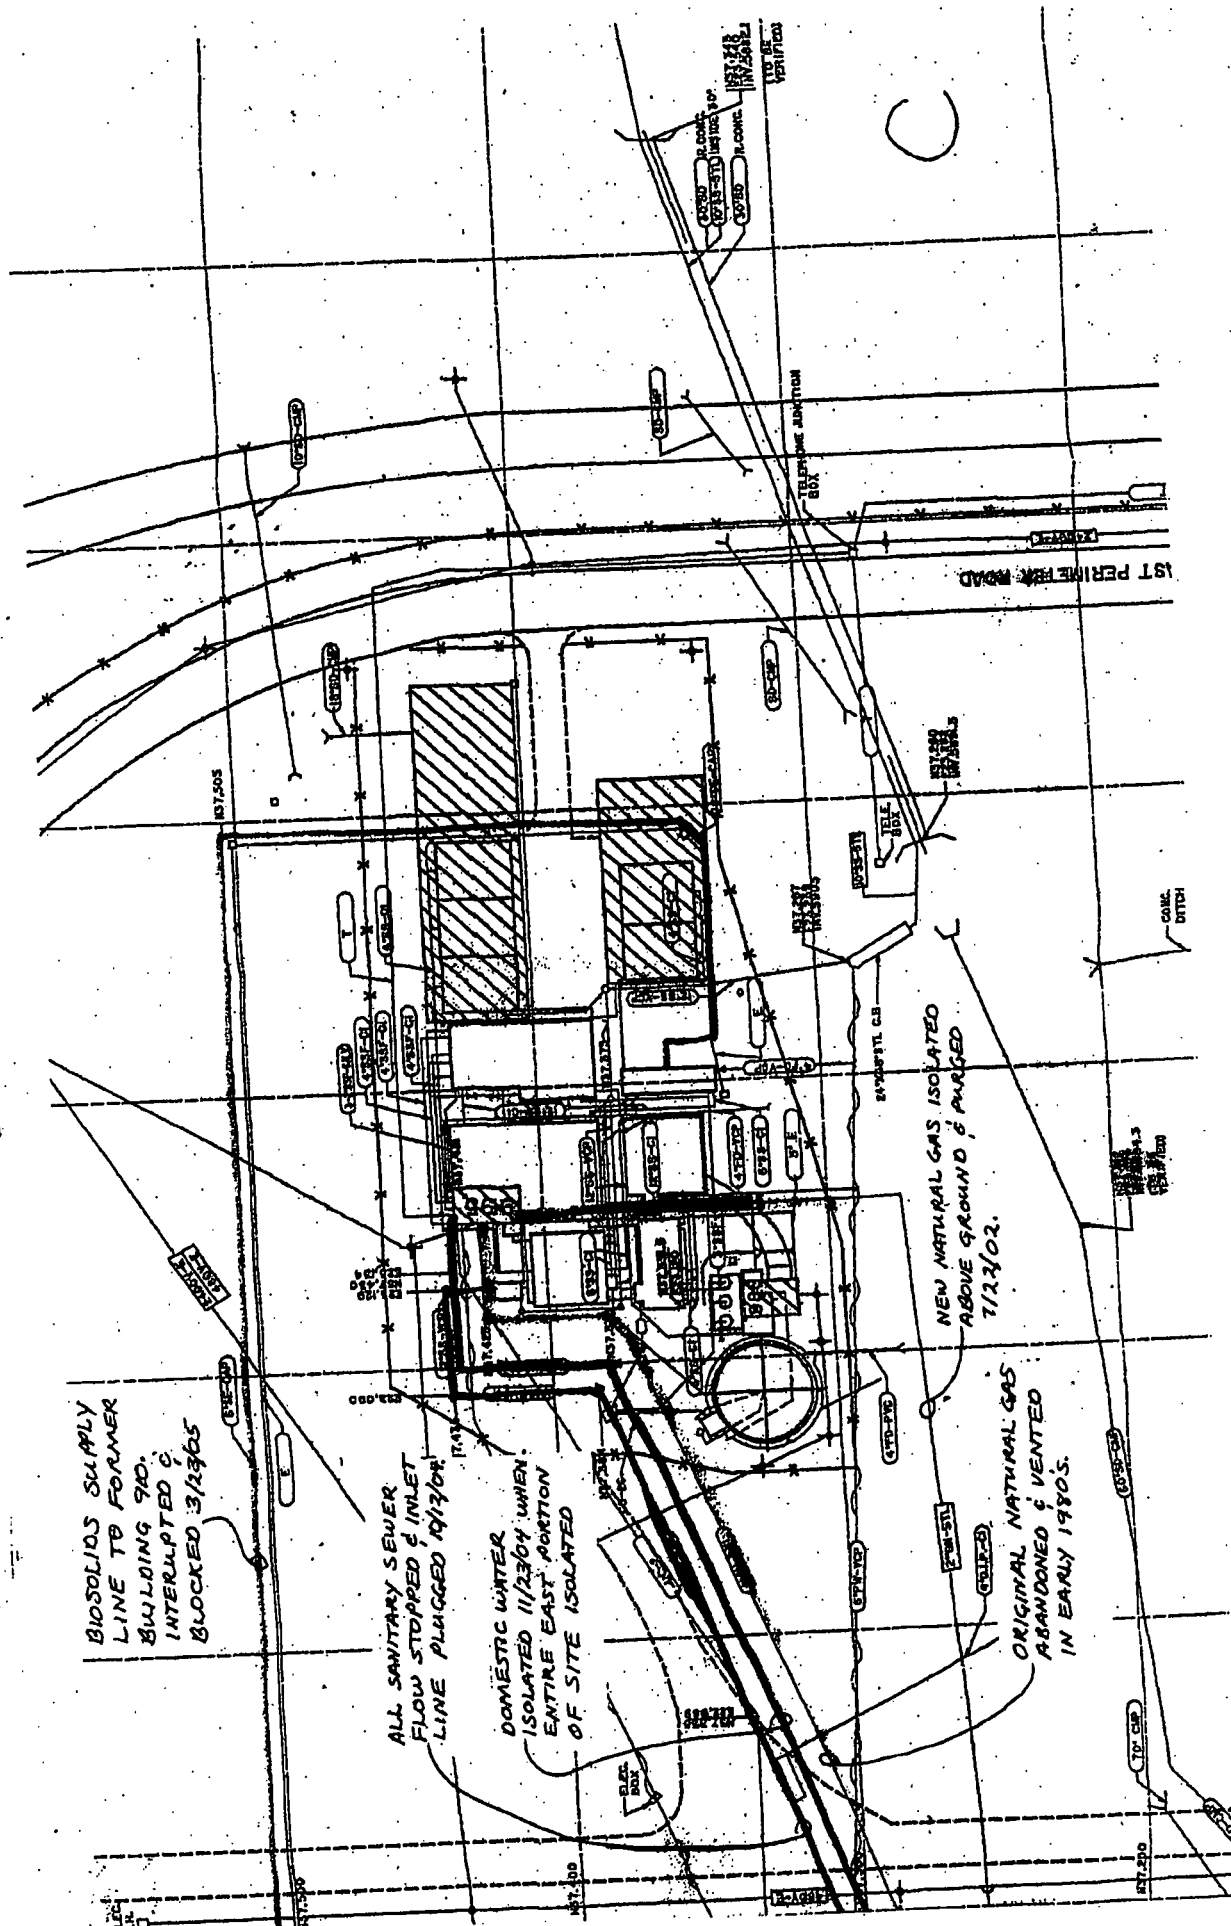
BIO-SOLIDS SLURRY  
LINE TO FORMER  
BUILDING 910.  
INTERLUPTED &  
BLOCKED 3/13/85

ALL SANITARY SEWER  
FLOW STOPPED & INLET  
LINE PLUGGED 11/21/84

DOMESTIC WATER  
ISOLATED 11/23/84 WHEN  
ENTIRE EAST PORTION  
OF SITE ISOLATED

NEW NATURAL GAS ISOLATED  
ABOVE GROUND & PURGED  
7/22/02.

ORIGINAL NATURAL GAS  
ABANDONED & VENTED  
IN EARLY 1980'S.

Attached to this report are Figures A, B C and D which show the utility removals and facility disposition. Buildings in the 990 area were removed as was the junction box identified as Manhole 146. The equalization basins were removed to 4 feet below final grade, then filled with clean fill. All of the structures in the 995 area were removed, including the sludge drying beds, the influent and effluent storage tanks, the digesters, all manholes and similar structures, and in ground lines. Some structural components of the buildings were left in place at least 4 feet below final grade, and are identified on Figure D. The main concrete structures left in place include partial walls of B995 and influent storage tanks 2 and 3 plus the foundations of the tertiary clarifier (C-5), one of the chlorine contact chambers (CCC-2), B988, and one effluent cell (EC-3). The PVC pipe foundation drain at the base of EC-3 was also left in place.

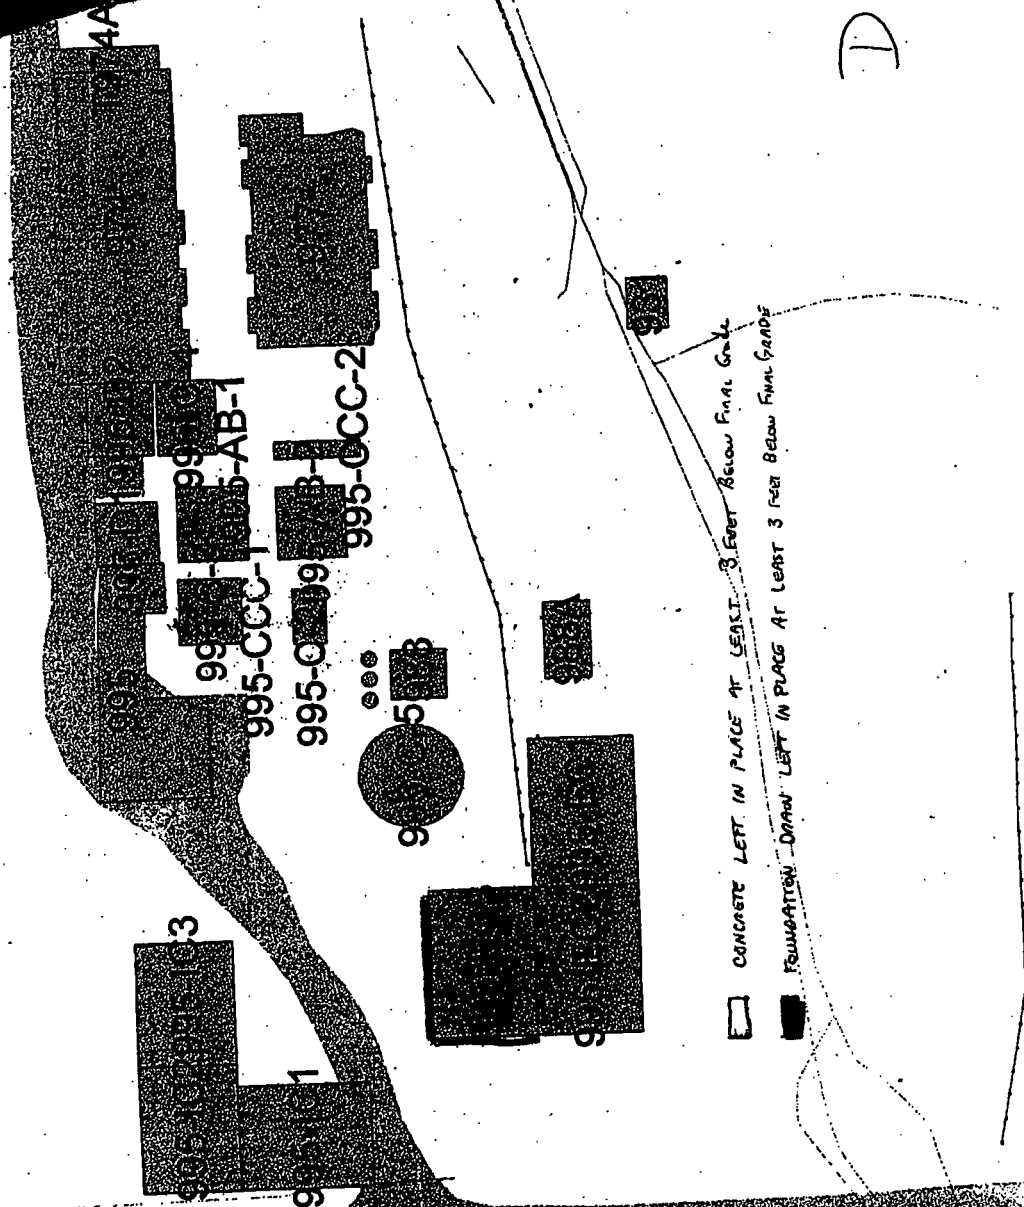
CONCRETE LEFT IN PLACE AT LEAST 3 FEET BELOW FINAL GRADE

FOUNDATION GRADE LEFT IN PLACE AT LEAST 3 FEET ABOVE
